# Guidance for Electricity and Gas Meter Installation Consumer Facing Issues

A guide for meter operatives on how to act and actions to take when identifying consumer facing issues

Energy UK

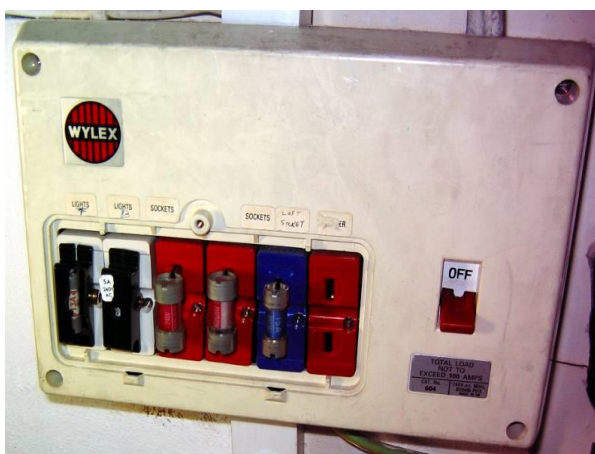
Exposed live fuse carriers and consumer unit lid missing – also 13a BS 1363 fuse in lighting circuit

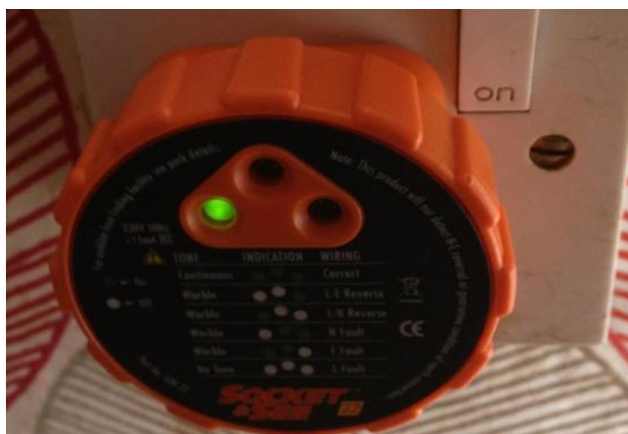
Clear illustration of a reverse polarity found on a customer's socket outlet whilst carrying out pre work polarity check.

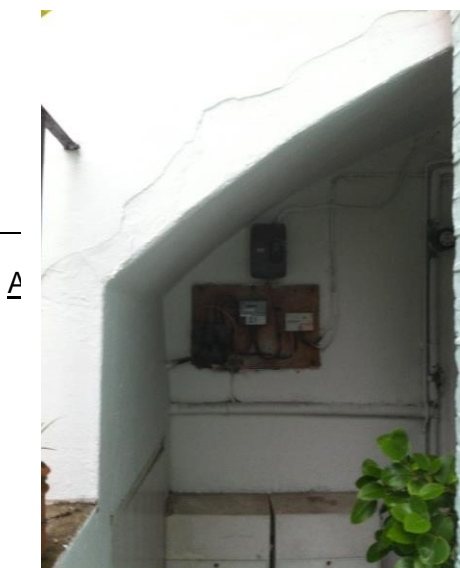
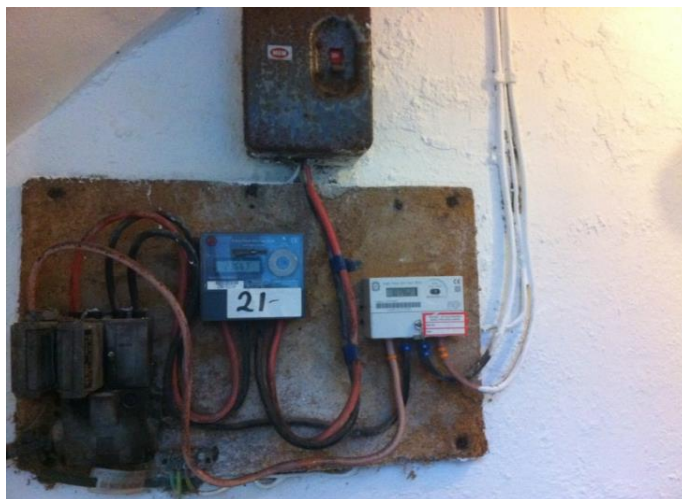
Two photographs illustrating a meter position which is now exposed to weather conditions. Connections to both the cut out, meter and customers switch fuse are severely corroded

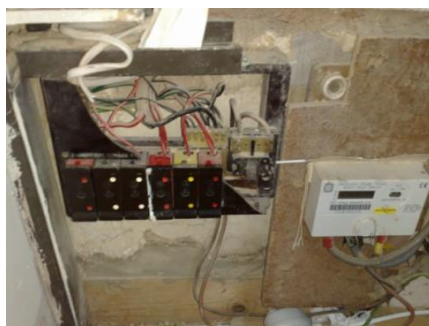
Customer's old Wylex consumer unit with severely damaged cover, exposing live terminals

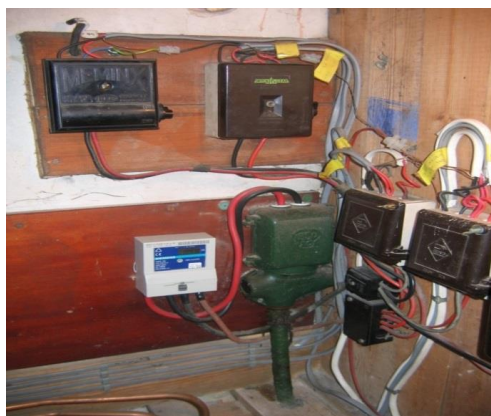
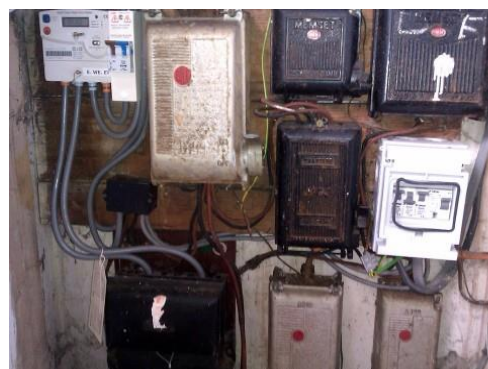
Both pictures show a collection of old single and two way 'fuse boxes'. Some visible signs of earthing but in poor condition and some units appear not to have an earthing provision

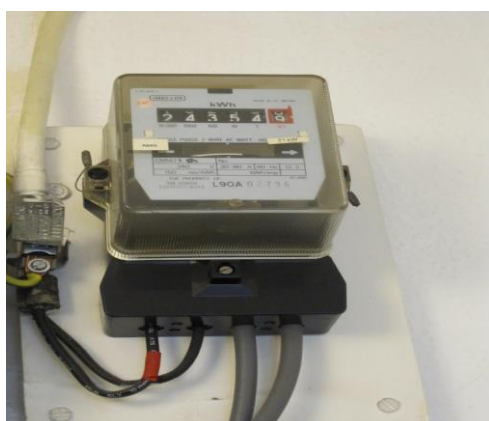
Shows an MICC (Pyro) cable terminated directly into a meter with no appropriate termination or means of local isolation

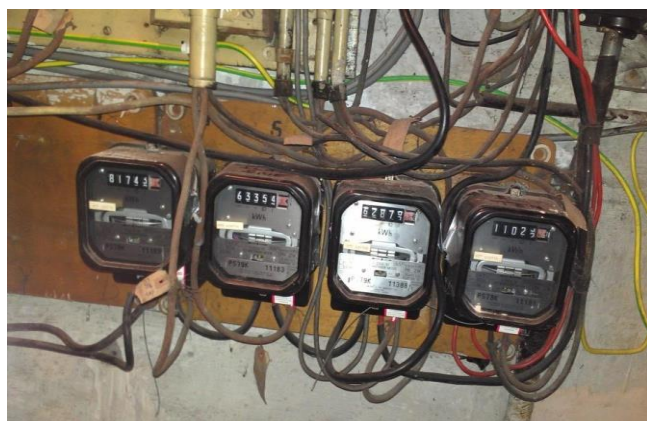
Shows a multi property service position with sub mains to properties in VIR single cables contained in conduit. VIR's appear deteriorated and movement of cables to fit a new meter could cause damage or potentially a 'flashover'

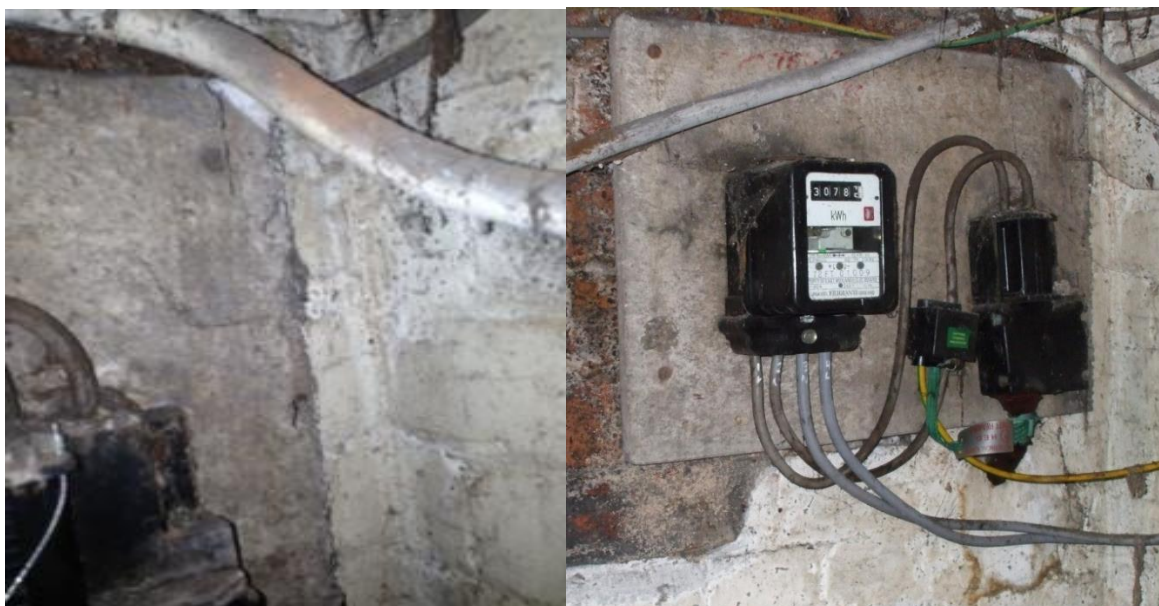
Both pictures show examples of a meter board which has been identified as containing asbestos materials. In close up it can be seen that the board is deteriorating, probably due to the damp conditions in the cellar location.

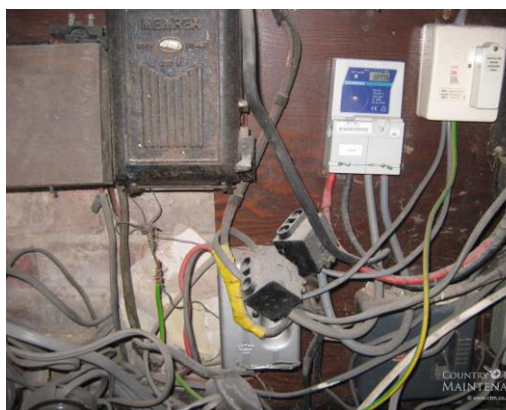
Shows a variety of unsafe consumers wiring, including lead cables, old metal cased consumer units, untidy cables etc.

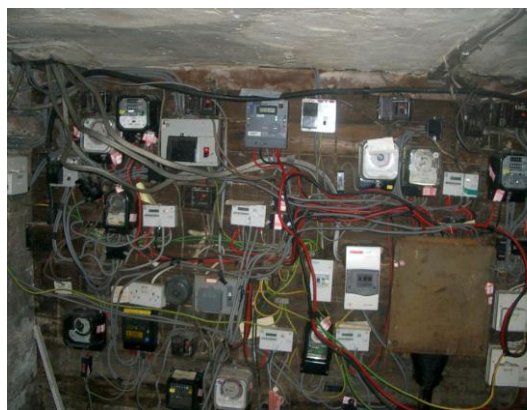
Whilst this picture identifies a particularly difficult cellar located service position, Close examination shows a variety of consumer wiring issues which will need to be taken into account when carrying out any meter installation activity.

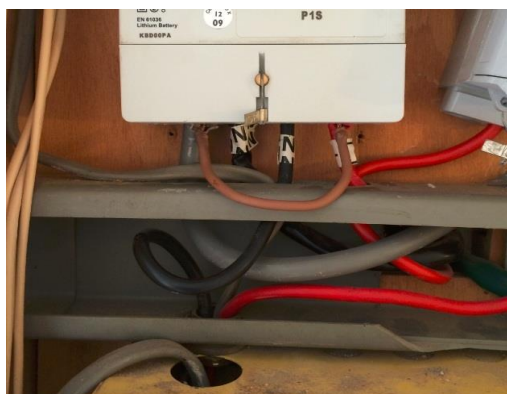
Example of meter by-passed

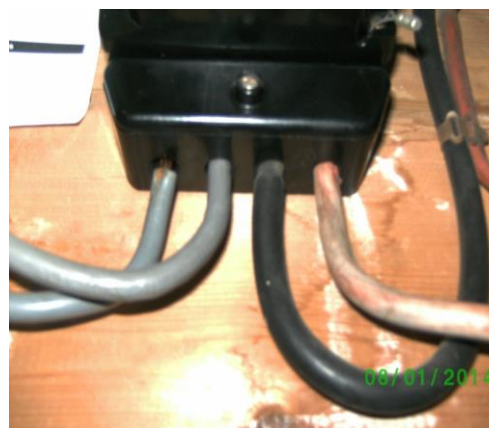
Previous signs of tampering

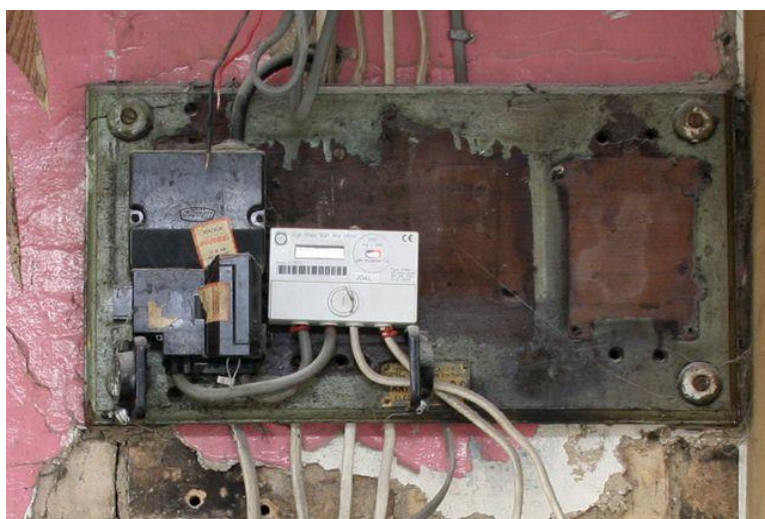
Picture shows a meter board in poor condition. Although not easily visible from this picture, the board shows previous signs of woodworm and is loose on the wall

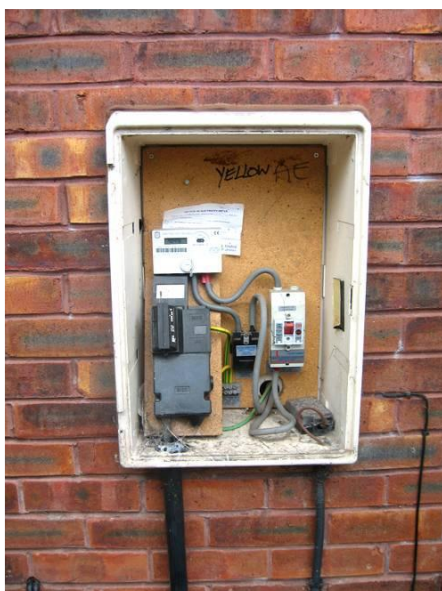
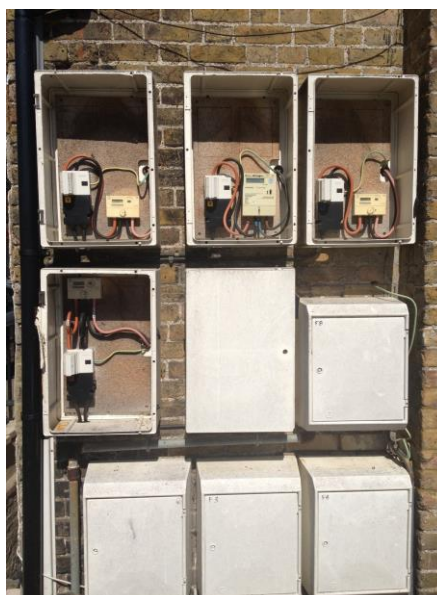
Both pictures show meter box doors missing, exposing equipment to damage, exposure to weather conditions etc. Hinges are missing in some instances and some minor box damage exists.

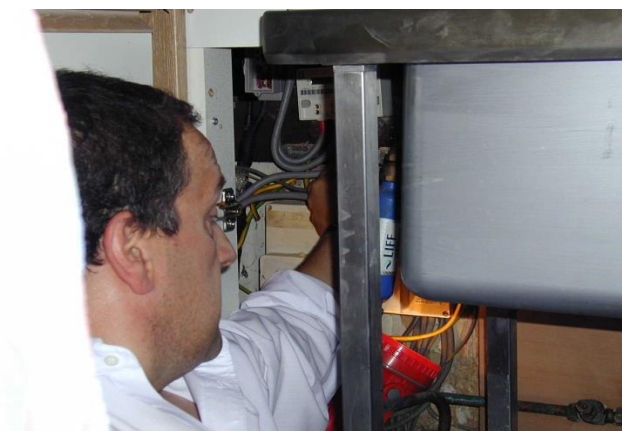
The photograph shows very restricted access to service position and consumers equipment located in a commercial kitchen environment.

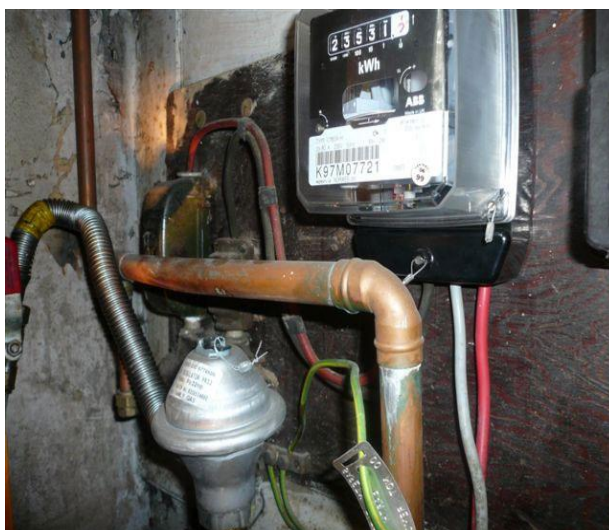
Picture shows a consumer's gas pipe located in very close proximity to the meter, tails and also restricting access to the metal clad cut out.

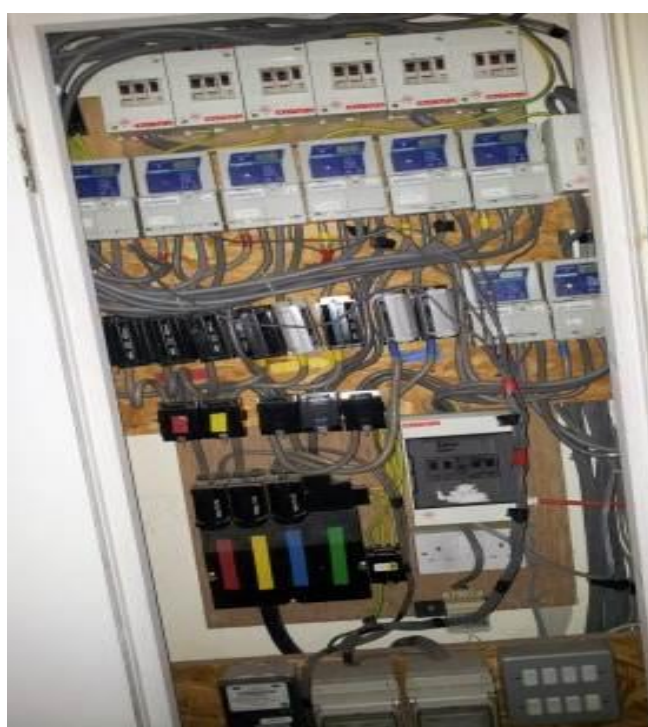
Although the use of space in this multi property installation has been constrained by the location, it may be difficult or impossible to install replacement smart meters so intervention on site may be necessary

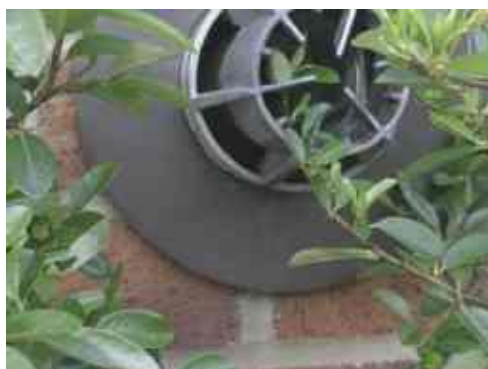
Although not fully blocked, this picture identifies a gas boiler flue which has vegetation encroaching on the outlet. Left unattended this will eventually cover the outlet.

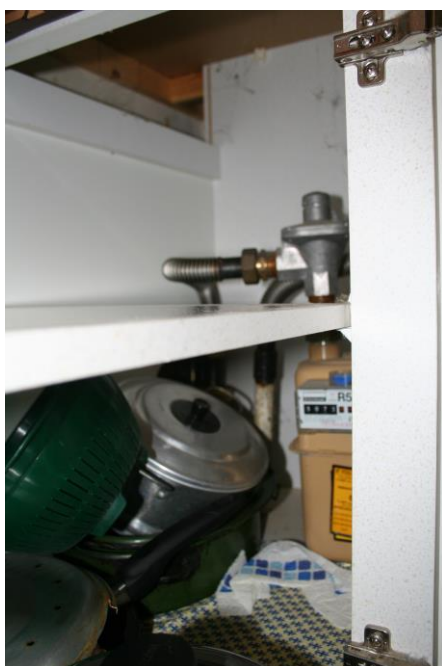
Picture shows gas meter position where kitchen units have been built around the installation. Although in this particular instance the meter may be able to be replaced with difficulty, the positioning may in other circumstances make it very difficult or impossible to replace the meter without consumer intervention

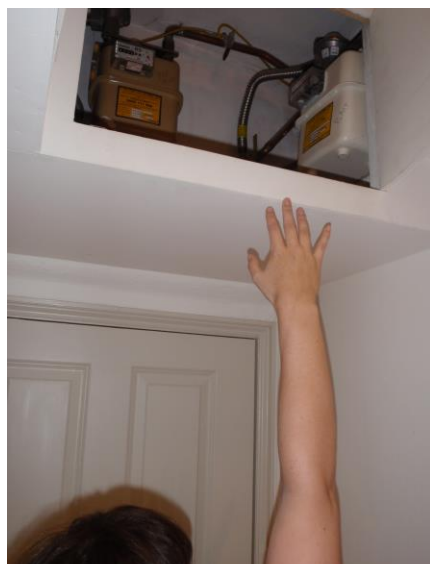
Picture shows a gas meter position located above a door approximately 8 feet high and inaccessible to the consumer without the use of a step-ladder etc.

In certain circumstances this type of location may also be very difficult to reach for the installer or be impossible to replace the meter in its current position

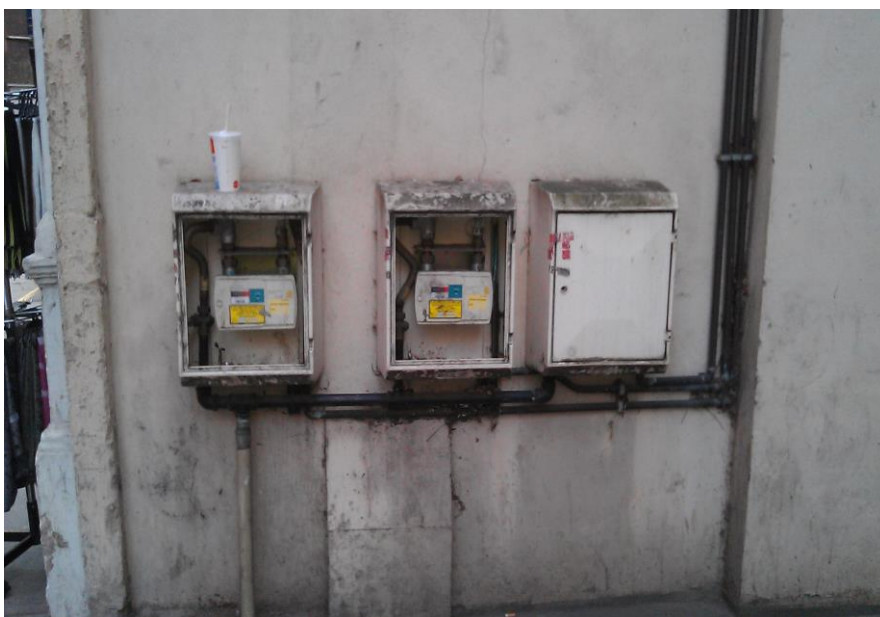
Picture shows gas meter box doors missing, exposing equipment to damage, exposure to weather conditions etc. Hinges are missing in some instances and some minor box damage exists.

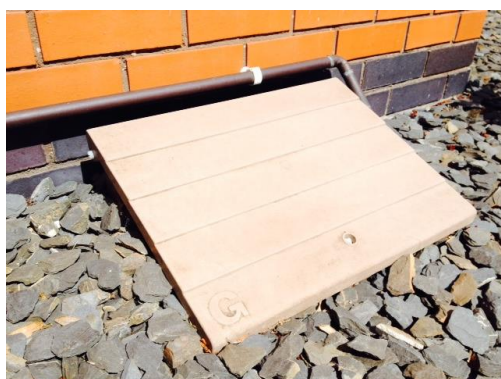
Picture shows a semi concealed gas meter box in a location close to an entrance path to a property.

In this instance the slate covering the ground may allow rain to drain away, but in other circumstances, ie on driveways this may create a situation where the meter box becomes immersed or partially filled with water.
