MOTOR CURRENT SIGNATURE ANALYSIS TO DETECT FAULTS IN INDUCTION MOTOR DRIVES—FUNDAMENTALS, DATA INTERPRETATION, AND INDUSTRIAL CASE HISTORIES

William T. Thomson

Ronald J. Gilmore

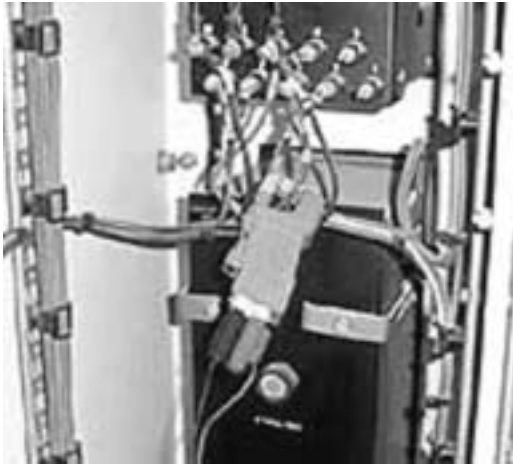
Figure 4. Small Clip-on CT Around the Secondary of Existing Instrumentation CT.

in Figure 4. Note that only one CT is required for MCSA, and it can be in any one of the three phases. The fundamental reason for this is that the rotating flux waves produced by the different faults cut all three stator phase windings, and corresponding currents are induced in each of the three phases.

The high frequency response is required to cover the frequency range of components that can be induced due to different fault mechanisms found in a wide range of designs of three-phase induction motors and also to cater for inverter fed (variable speed) induction motor drives. If necessary, more technical details on in situ instrumentation CTs and clip-on CTs of the type shown in Figures 3 and 4 will be provided at the actual tutorial presentation.

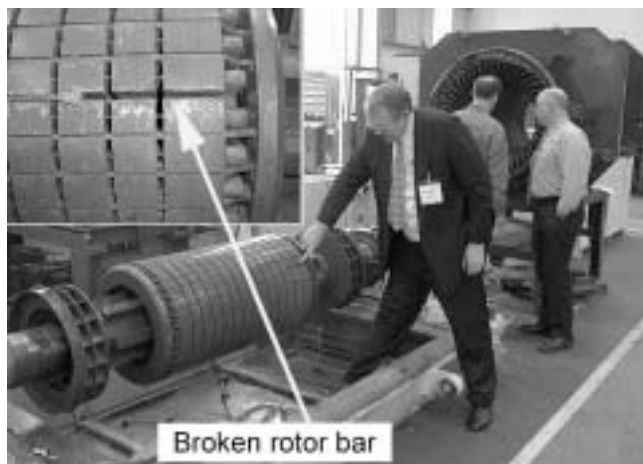
Figure 7. Broken Rotor Bar Lifted out of the Slot.

winding failure may follow, resulting in a costly repair and lost production. Figure 7 shows a case where a broken rotor bar had lifted in the slot, and the resultant damage to the high voltage stator winding is shown in Figure 8. (Figures 7 and 8 refer to a three-phase, 11 kV, 2900 kW (3887 hp), 179 A, 50 Hz, 2978 rpm, squirrel-cage induction motor (SCIM).)

It will now be shown how MCSA avoided the type of problems that had previously occurred and are shown in Figures 7 and 8. Failure of this crucial motor was prevented.

The broken bar factor = 0.79, but Equation (3) is for full-load operation and this has to be corrected since the MCSA measurement was taken on reduced load. Applying the correction factor for this load and particular motor design (commercially sensitive and cannot be released), then the broken bar factor is: $n = 1.15$. It was therefore predicted that there was definitely one bar completely broken. There was also a risk of the broken bar lifting out of the slot with consequential mechanical damage to the HV stator winding and failure as was illustrated in another case as shown in Figures 7 and 8.

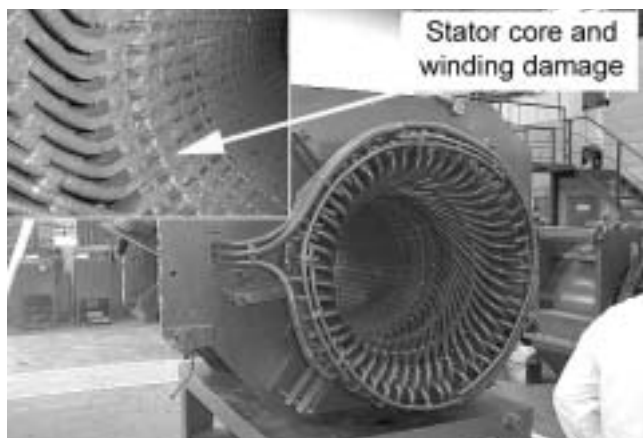
Figure 8. Mechanical Damage to HV Stator Winding.

The repair cost was \$160,000 for a replacement rotor and a complete rewind of the stator winding. Fortunately there was a dual drive train to deliver the process on the offshore oil production platform, but this is not always the case since single drive trains are now more common to reduce capital cost, weight, and size of offshore oil production platforms. In hazardous environments, sparking at the fault site during the degradation process can be a potential safety hazard. Operators of large high voltage induction motors cannot take unnecessary risks, hence MCSA is now being extensively used to assess the operational condition of rotor cage windings.

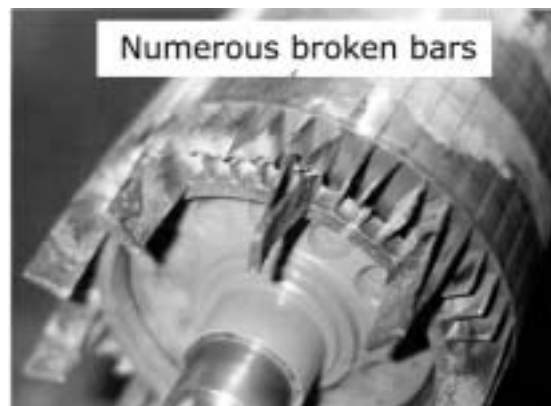
Figure 9. Crane Motor—Broken Rotor Bars.

Additional examples of broken rotor bar failure are shown in Figures 9 and 10. The rotor in Figure 9 was from a crane motor subjected to DOL starts and had a long run up time (45 sec!). This rotor was not fit for purpose and was not producing sufficient starting torque for the load starting condition. Note the narrow bars and the classic crescent-shape breaks of the actual bars. Figure 10 shows a rotor from a food mixer motor that was being subjected to 24 starts per hour, which again was just too arduous a duty cycle for the rotor design. New designs were implemented and the problems were eliminated.

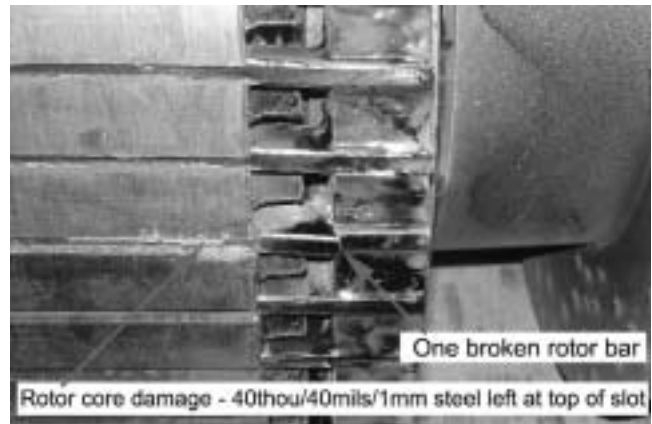
Figure 15. Faulty Rotor Winding Diagnosed via MCSA—Prevented Secondary Damage to HV Stator Winding.

located in storage. The spare one was refurbished by the manufacturer since it had been in storage for 14 years. The faulty rotor was removed and the replacement one installed with a total planned outage of five days on the offshore oil and gas production platform. Note that special scaffolding had to be constructed, etc., for removal of the rotor within the modular construction. Inspection of the faulty rotor, as shown in Figure 15, proved that the diagnosis was correct and that there was one completely broken rotor bar. In fact there was only 40 thou/40 mils/1 mm of laminated steel left at the top of the slot, and note the damage to the rotor core. There was a very high risk of the broken bar lifting out of the slot with consequential mechanical damage to the HV stator winding and a very lengthy outage as previously discussed.

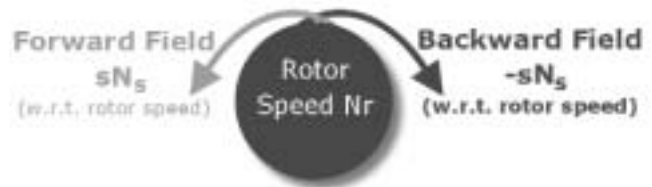
Figure A-3. Illustration of Forward and Backward Rotating Fields from Rotor Currents When a Broken Bar Exists.

With broken rotor bars there is an additional rotating magnetic field produced. Broken rotor bars produce a backward rotating field at slip speed (-ve direction ($N_s - N_r$) = sN_s) with respect to the rotor as illustrated in Figure A-3.
